Chapter 3

THE ACCOUNT OF WORLD TRADE CENTER 2

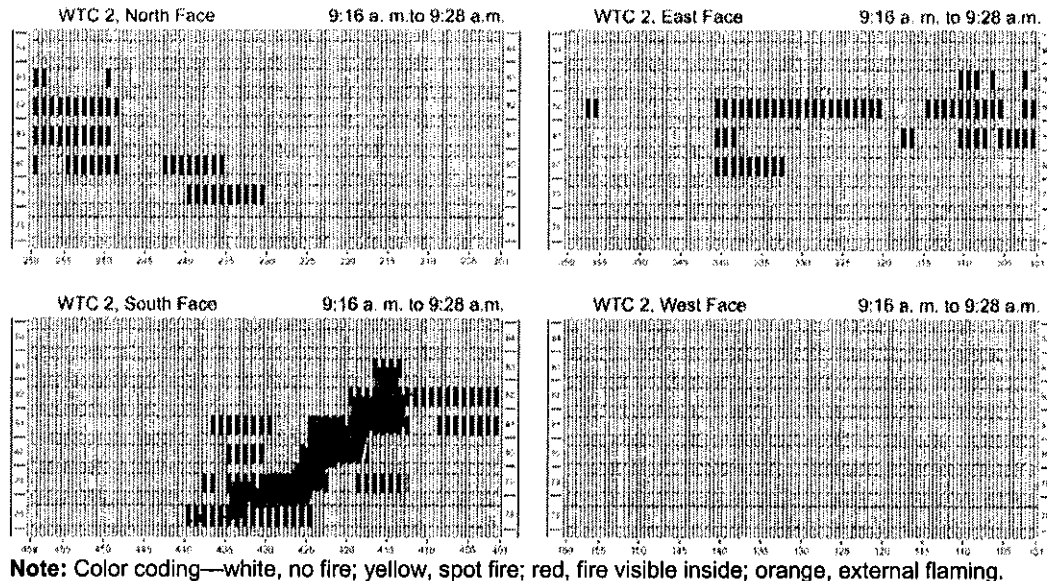
For the next half hour, small fires were burning in and near the aircraft impact cavity on the south side of the building. There were vigorous fires on the east side of the 80th through 83rd floors (Figure 3-4), especially on the northeast end of the 81st and 82nd floors, where the aircraft had bulldozed the office desks and chairs and added its own combustibles. In addition to the ample supply of fuel, these fires had access to plenty of air, as numerous windows on the east face had been blown out by the impact or fireball. They would continue to burn as long as the building stood.

Figure 3-4. Representation of exterior views of the fires on the four faces of WTC 2 at about 9:20 a.m.

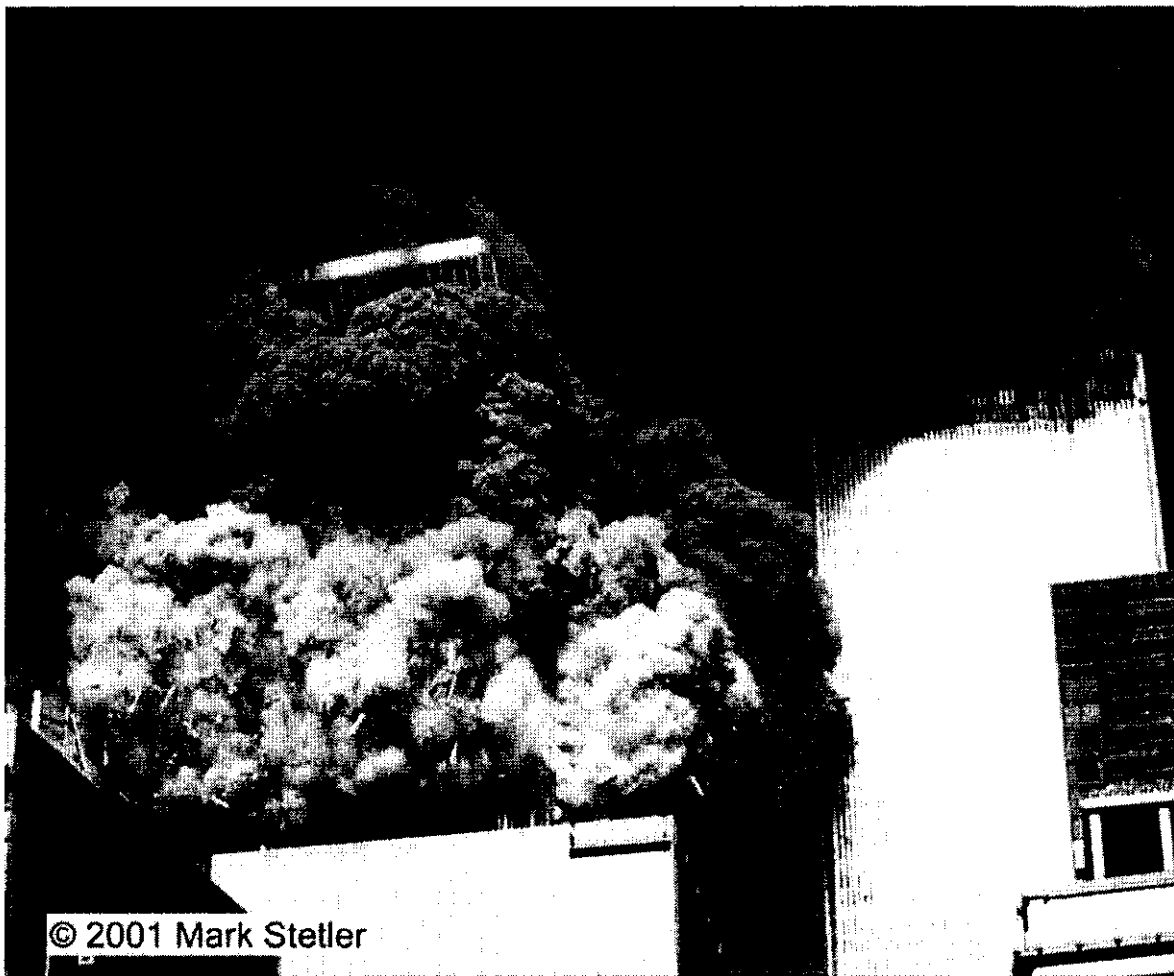
The physical condition of the tower had deteriorated seriously. The inward bowing of columns on the east wall spread along the east face. The east wall lost its ability to support gravity loads, and, consequently, redistributed the loads to the weakened core through the hat truss and to the adjacent north and south walls through the spandrels. But the loads could not be supported by the weakened structure, and the entire section of the building above the impact zone began tilting as a rigid block to the east and south (Figure 3-5). Column failure continued from the east wall around the corners to the north and south faces. The top of the building continued to tilt to the east and south, as, at 9:58:59 a.m., WTC 2 began to collapse.

Figure 3–5. Photograph of WTC 2 tilting to the southeast at the onset of collapse.

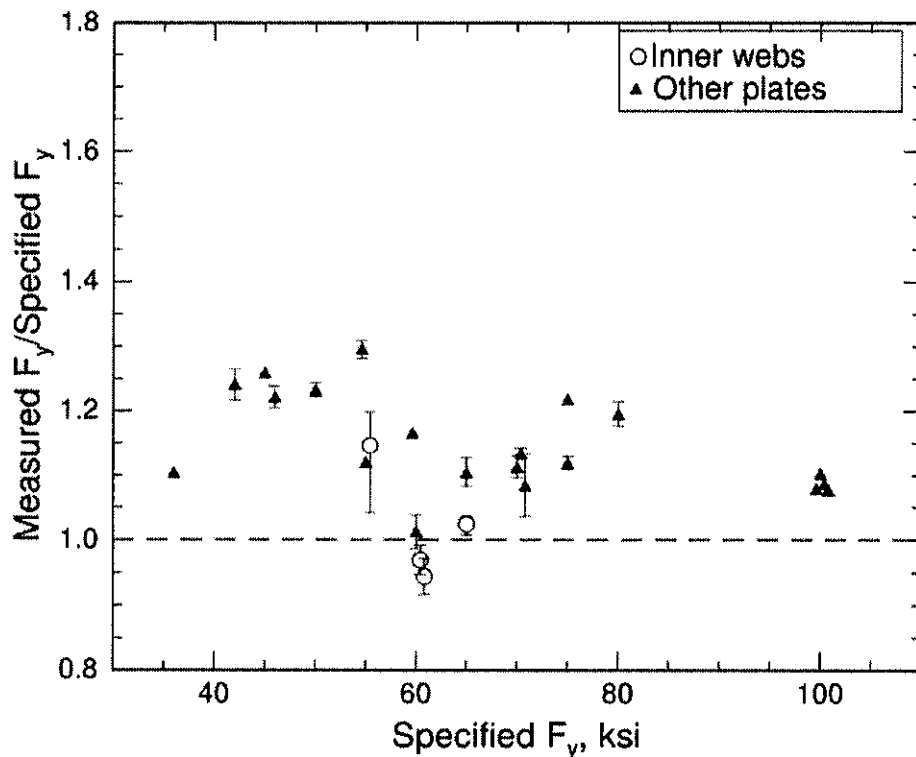
- Roughly 13 percent of the measured strength values for the perimeter and core columns were at or below the specified minimums (Figure 5–4). The strength variation was consistent with the historical variability of steel strength and with the effects from damage during the collapse of the towers. The measured values were within the typical design factor of safety.

Note: The ratio values less than 1 arose from natural variation in the steel and did not affect the safety of the towers on September 11, 2001. The bars represent maximum and minimum values from multiple measurements.

Figure 5-4. Ratio of measured yield strength (F_y) to specified minimum yield strength for steels used in WTC perimeter columns.
